Public Buildings Enhanced Energy Efficiency Program

Investigation Report for Century College

1/18/2012

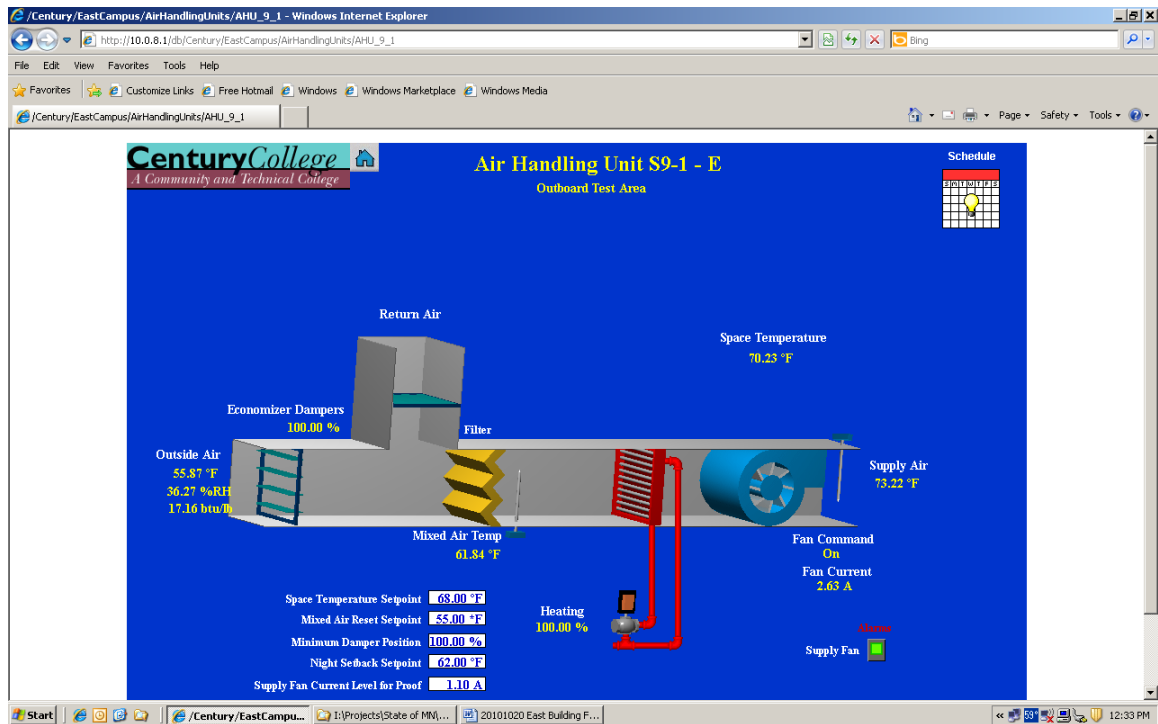
- b. The hot water valve is modulating open even though the supply fan is not running and the outside air temperature is above freezing conditions.
 - c. The heating valve is open when the BAS indicates closed. The valve is 0% open (100% Closed at indicated on the graphics page), the mixed air temperature is 63 degF and the supply air temperature is 73 degF. See screen capture below.

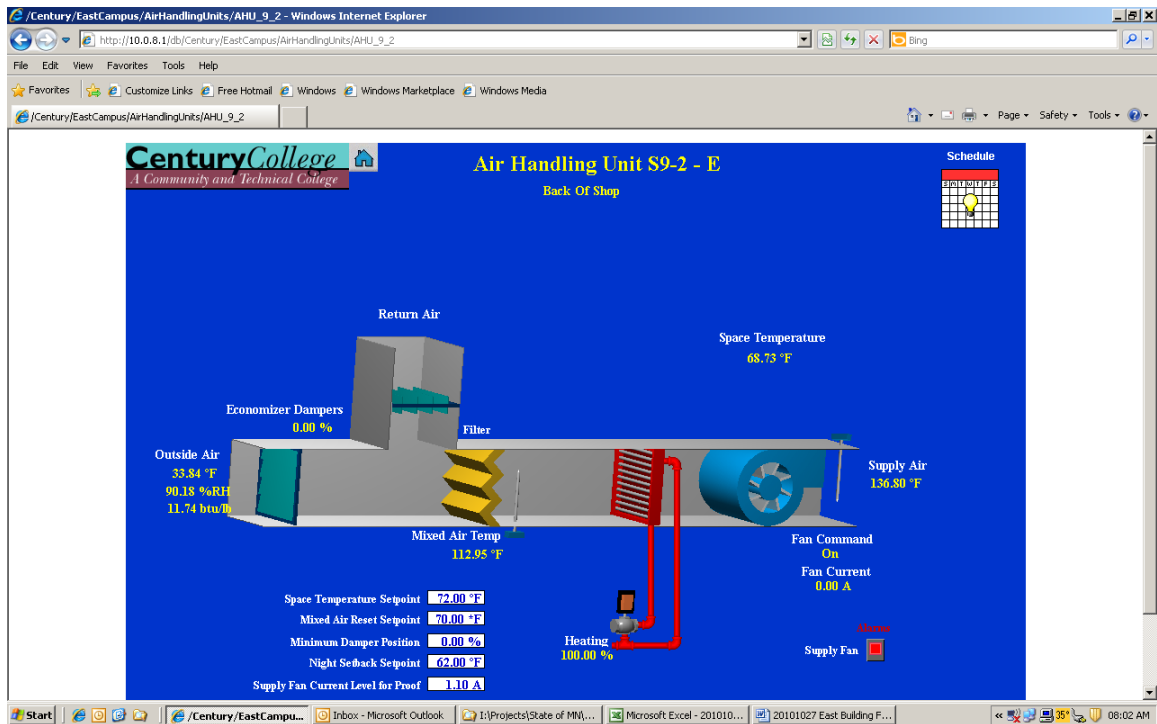
- d. When the fan is not running, the heating valve is open when the BAS indicates closed. See screen capture below.

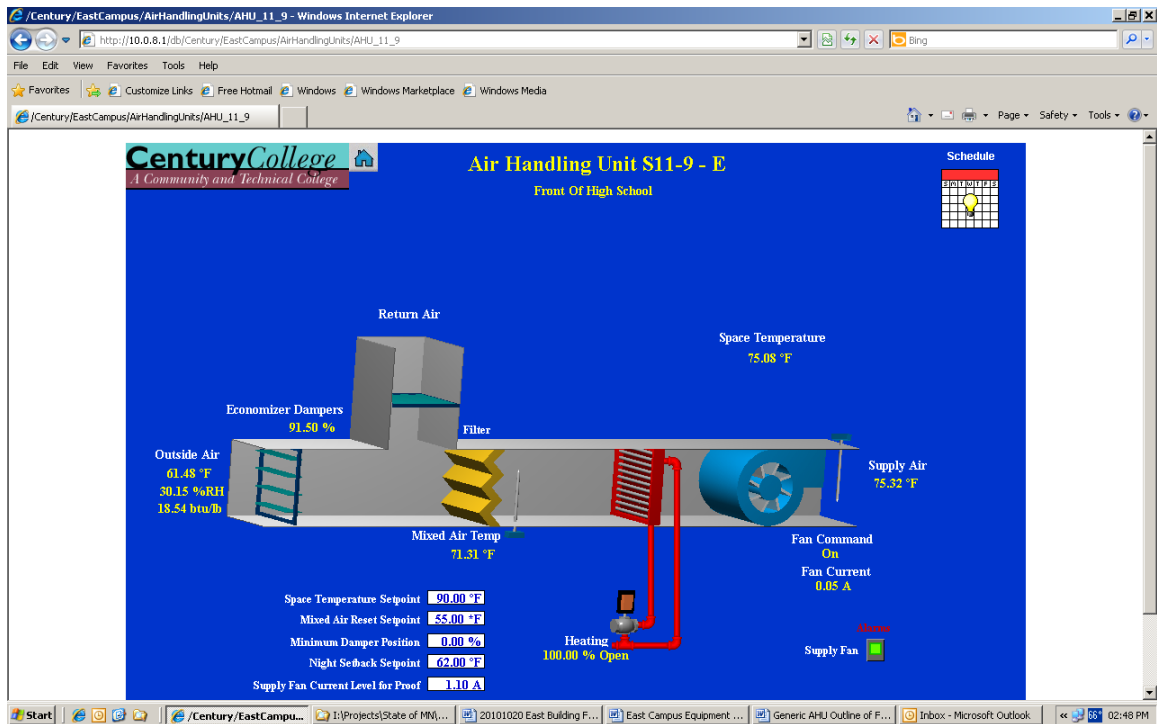
- b. The heating valve does not open as commanded by the BAS. Took screen capture (see below)
- 40. Retrofit - Energy/Heat Recovery
 - a. Verify the exhaust in this area to evaluate the consideration of adding a heat recovery system.

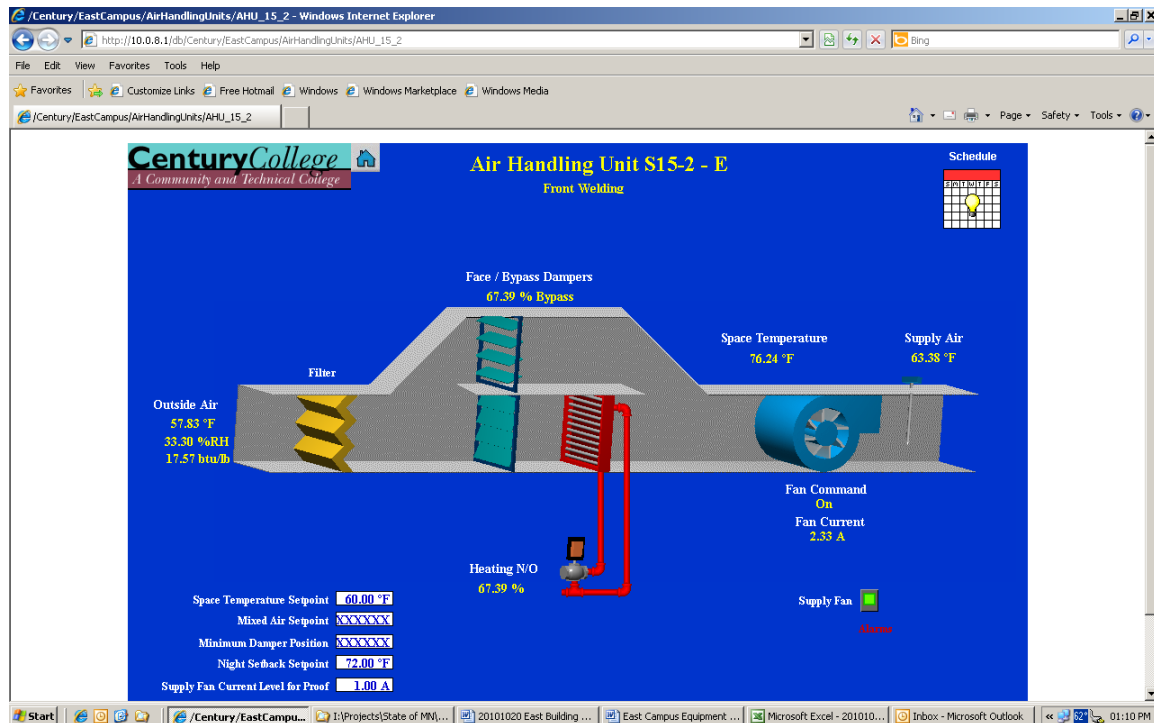
1. Equipment Scheduling and Enabling: Time of Day enabling is excessive.
 - a. The BAS schedule is listed at M-F 6am – 5pm for a total of 55 hours/week. Will need to verify class schedule for actual occupancy of area.
11. Control Problems: Other
 - a. The heating valve does not open when commanded by the BAS. Took screen capture below; the supply air temperature does not change as the valve position changes.
13. Controls Setpoint Changes: Zone setpoint setup/setback are not implemented or are sub-optimal.
 - a. No night setup/setback. Night setback is set to the same temperature as the daytime space temperature setpoints. See screen capture.
40. Retrofit - Energy/Heat Recovery
 - a. Verify the exhaust in this area to evaluate the consideration of adding a heat recovery system.

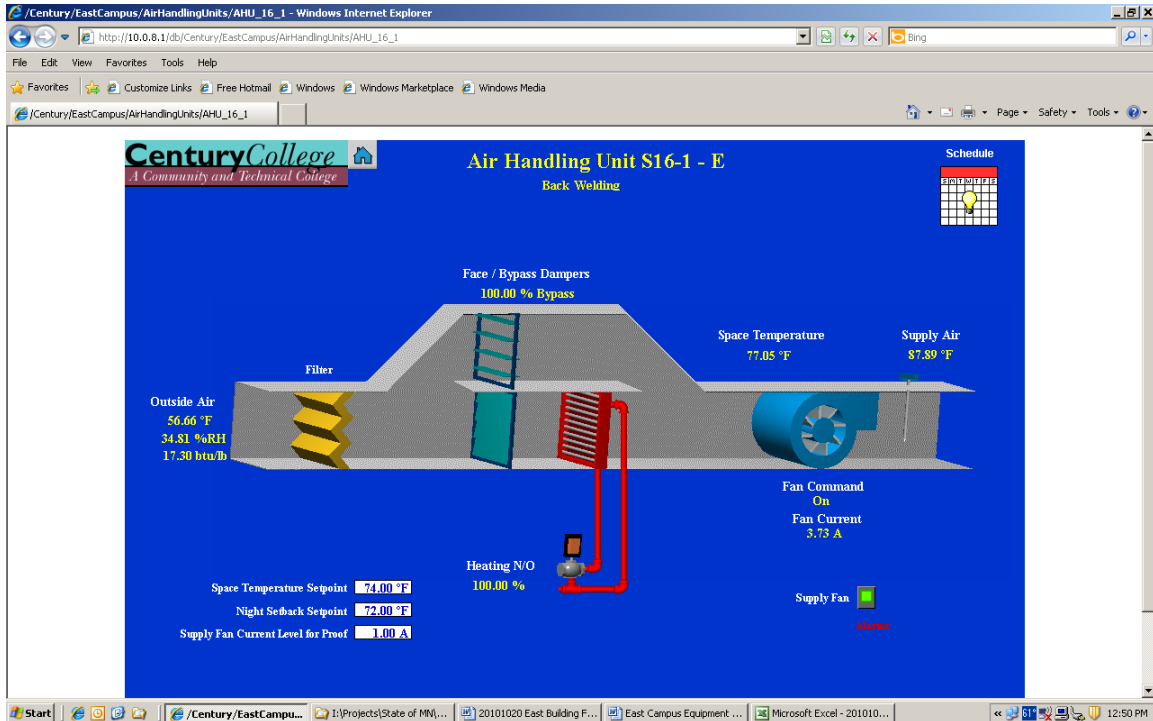
- a. The heating valve is open when the BAS indicates closed. Supply air temperature at 88 degF when valve indicates closed. Took screen capture below.
40. Retrofit - Energy/Heat Recovery
- a. Verify the exhaust in this area to evaluate the consideration of adding a heat recovery system.

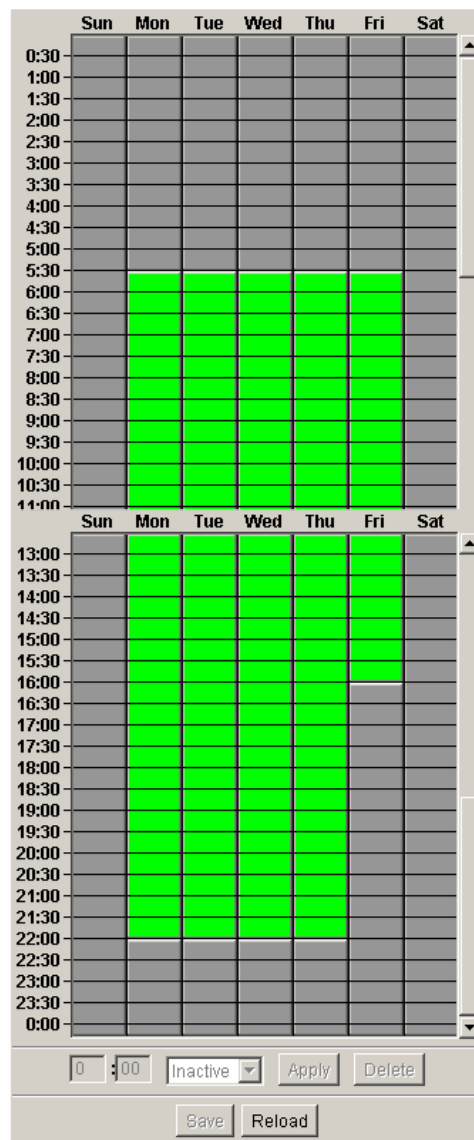
Weekly Schedule: /Century/EastCampus/Schedules/Master_TechWing_AHU_Schd

1. Equipment Scheduling and Enabling: Time of Day enabling is excessive.
 - a. Took screen capture of schedule. Does not match actual building occupancy. The BAS schedule is 76.5 hours/week. Actual Schedule – M-Th-7am – 10pm F-7am-3:30pm and Sat-7:30am – 3:30pm for a total of 76.5 hours. The summer hours vary and closed during all school breaks; see website for closed hours. (Matching school occupancy schedule results in negative savings.)

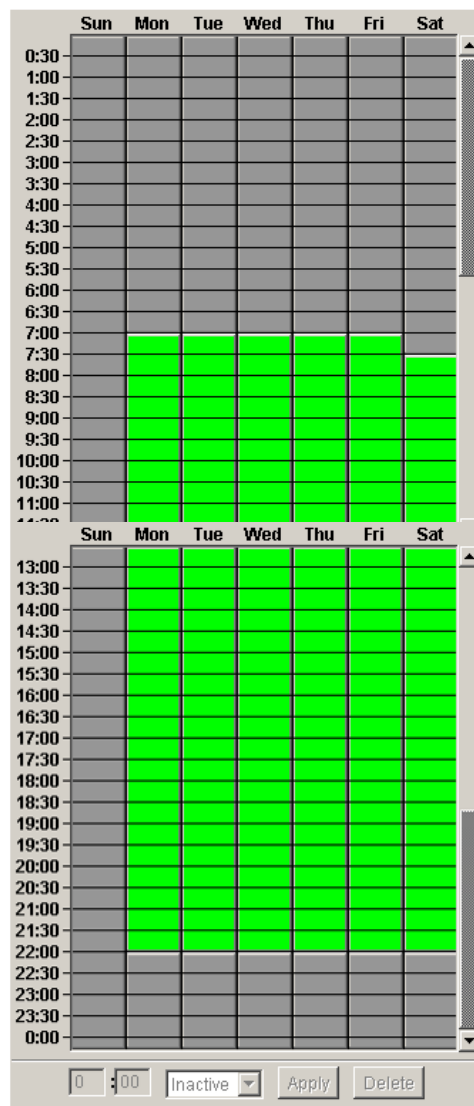
Weekly Schedule: /Century/EastCampus/Schedules/EF_64_Schedule

- a. Took screen capture of schedule. Does not match actual building occupancy. The BAS schedule is 89.5 hours/week. (Resultant savings are not great enough for a justifiable ECO.)
